# Refractory Considerations for Structural Components of Coreless Induction Melting Systems

## ABSTRACT

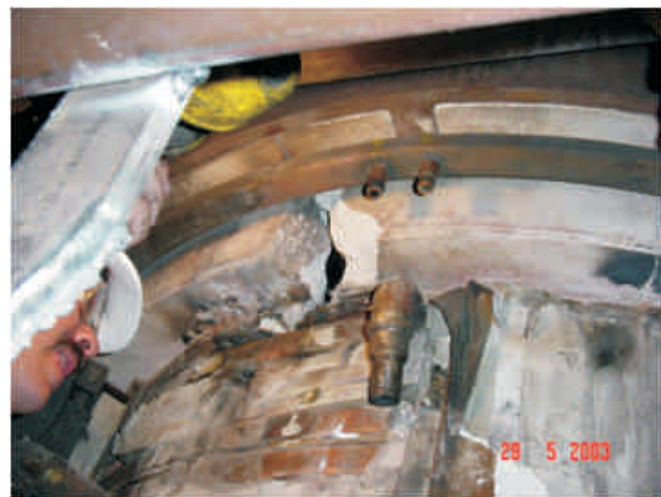
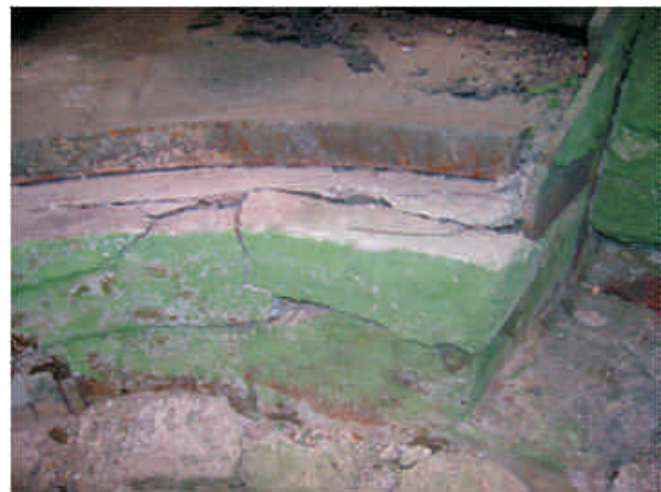
Figure C

Foundry A is a large automotive plant with 2 – 23 mt coreless furnaces for melting ductile iron. Furnaces were installed new, but after just 1 month of operation castable upper rings became damaged. Ring were made from conventional 90% alumina castable from a local manufacturer. The lining lasted run for 80 to 100 heats before showing ground. Personnel removed the top cap to find that metal had penetrated the cracks in the upper 1/3 of the furnace. Repairs had to be made to the upper rings and the grout in the top portion of the furnace. This caused delayed sinter and slow initial melt times due to reduced power caused by ground fault. It was determined that cracking was due to insufficient structure of the upper support castable ring. The Allied Mineral Products proposed a new material better suited for the application and a new design.

The castable was changed from a high alumina to a mullite based low cement castable. The ring was constructed with 4 different sections. The two side sections used an addition of 3.5% 310 SS needles of varying lengths. The

pouring spout and del sagging spout sections used 7% 310 SS needles of varying lengths. By changing the material used, by adding stainless steel fibers for improved thermal shock and by modifying the design of the upper rings, foundry A now achieves two years life from the upper rings with minimal cracking and no effect to the working lining. Foundry A was able to increase the lining life from 80 heats to 200 heats. Most important was decreased down time, reducing repairs required to the coil due to metal penetration and increased safety of operation.

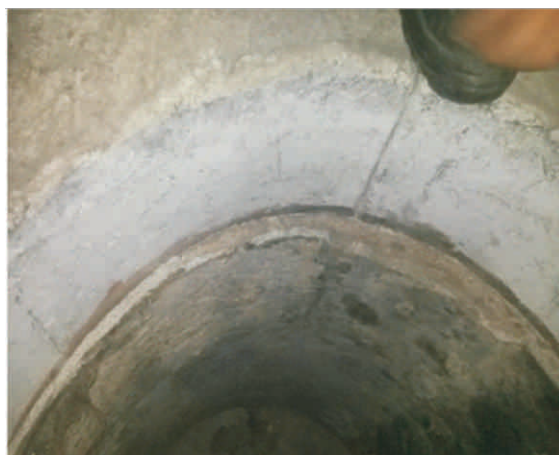
In **Figure H** you can see that the furnace has an improper transition of the upper ring to the grout surface. This has resulted in a ledge being created at the area where the two come together. The resulting ledge has restricted the movement of the working lining during heating and cooling. During heating and cooling of the working lining

**Figure H** Ledge between the coil grout and the upper ring

the refractory will expand and contract in a vertical plane. Any irregularity in the surface of the grout or the rings can cause the lining to hang-up during this process resulting in horizontal and random cracking due to stress. This type of cracking is the result of mechanical stress and will not seal upon re-heating. This can lead to metal penetration and possible damage to the furnace and put operators in harm. **Figure I** is the result of this improper construction of the grout and rings. The top portion of the lining could not contract naturally once cooled. This resulted in severe metal penetration in the top portion of the furnace. Not only did this create long and frequent down time but also damaged the top block. **Figure J** below also illustrates the need for a smooth grout surface. A smooth grout surface is very difficult with a standard conventional castable. It can only be achieved consistently with a refractory designed specifically for coil coating.

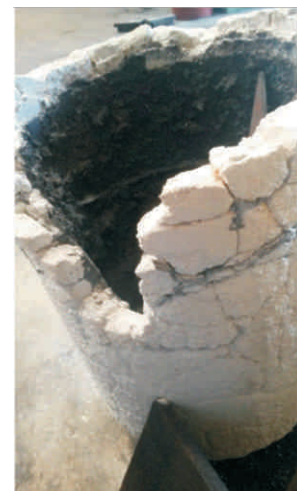
**Figure I** Cracking as the result of the lining hanging up

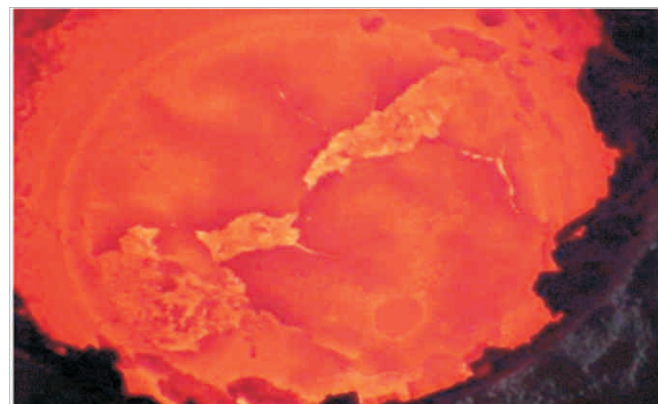
**Figure K**

The photograph in figure K is an example of one foundry that never considered drying the push out plug. There reasoning was that the moisture will be driven down and away from the working lining. Although that may be true in principle but at the initial stages of the sinter temperatures are not high enough and the steam rises before higher temperature and pressure force it down. This is a 10mt furnace for melting iron. In every new lining approximately 2" of the lining would spall resulting in an early patch and lower lining life. It was found that the steam generated by the push out plug was forcing the top layer of the refractory to peel off. The foundry was given a controlled sinter cycle for drying the plug before use. After the proper process was followed the spalling was eliminated.

Any moisture left in the structural components can react with the refractory matrix or the bonding system and cause early lining failure or worse, catastrophic failure. Had this foundry practiced liquid sintering the results could have been much worse.

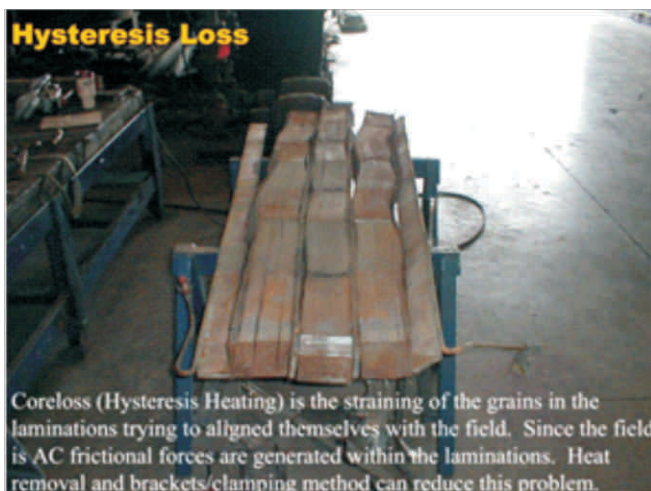
Figure N represents shunts and yokes that have not been maintained properly

The yokes and the shunts need to be maintained and replaced on a regular basis in order to maintain the efficiency of the melting furnace, but it is also important for the longevity and safety of the refractory working lining.

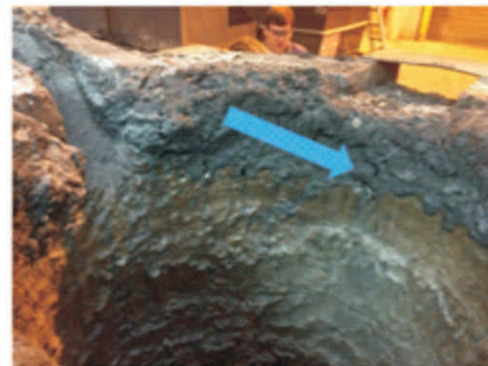
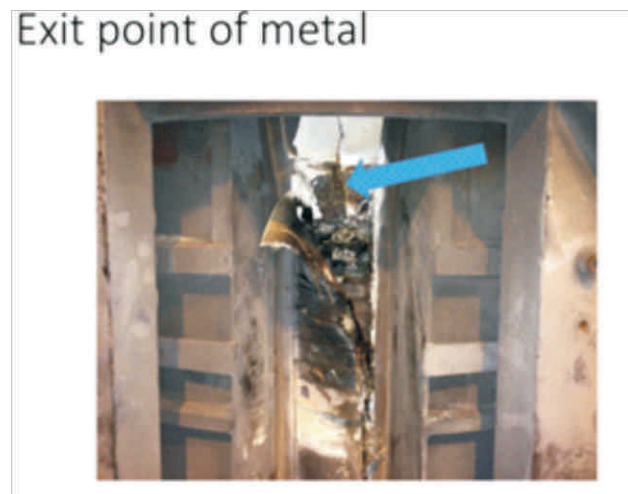
Foundry D operates a 5mt coreless furnace for melting iron. Recently the furnace experienced a sudden and unexpected runout in the top of the furnace. Lining was running great, no GLD notifications, no increase energy consumption and no signs of a problem. Suddenly metal ran through at 3 O'clock position.

### Crack at 3 o'clock below slag trough

Fig O (a) Metal Run Out Fig O (b) Metal Run Out

The exit point of the metal was directly behind the expected problem area.

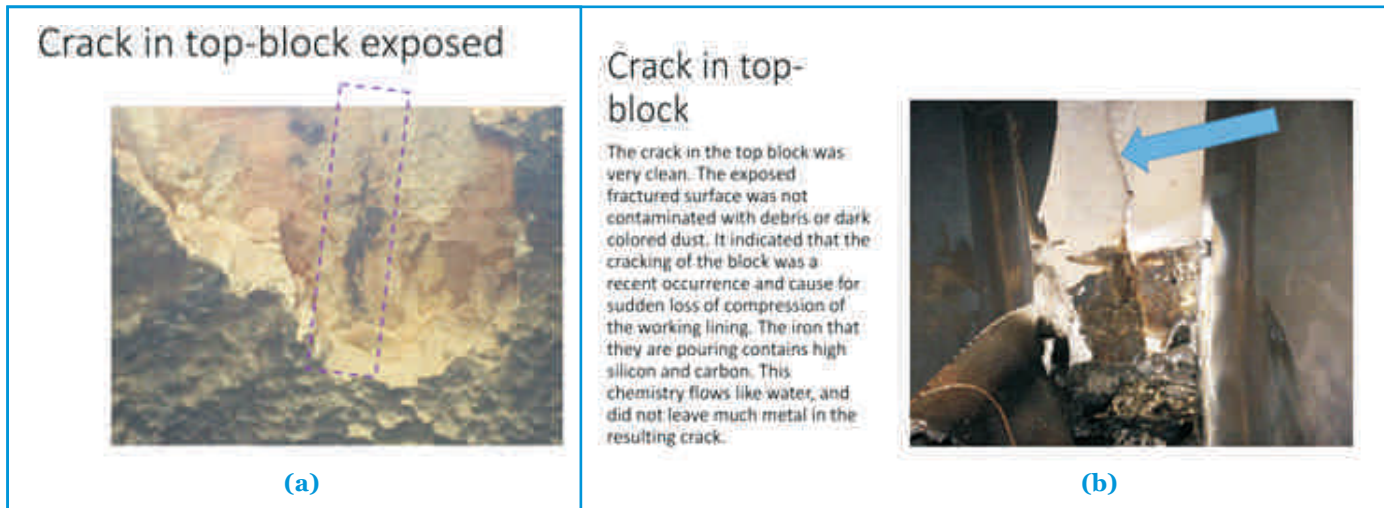
**Fig. P (a,b) : Cracks in Top Block**

After removing the top portion of the silica lining a crack in the upper support block was noticed. This crack had not been seen during the lining of the furnace.

Once the refractory had been completely removed the crack on the inside of the upper block was inspected. The crack was found to be very clean and newly formed. The OEM checked the shunts and found they were loose.

It was the conclusion of the OEM, the customer and Allied Mineral Products that the shunts had loosened to a point that the lining shifted, cracking the top block and the top portion of the refractory. Shunts were tightened according to OEM specifications. They were found to be very loose. Top Block was replaced and the furnace has been back in service for months with no issues.
